Natural Environment Study

Unincorporated Community of Jamul

San Diego County, California

The County of San Diego proposes to replace Lawson Valley Road Bridge, which has become structurally and operationally deficient. The bridge was built in 1948 and measures 21.5 feet wide and 27.75 feet long. Emergency repairs were performed on the bridge in February 2002. These repairs were necessary to prevent the collapse of the northeast side of the bridge. The California Department of Transportation (Department) has classified the existing bridge as structurally deficient. The proposed replacement project would remove the existing bridge and install a new crossing in the same location that satisfies all requirements under the Federal Highway Bridge Replacement Program, including compliance with American Association of State Highway and Transportation Officials' (AASHTO) geometrics, Federal Emergency Management Agency (FEMA) Flood Control, and National Environmental Policy Act (NEPA) requirements. This bridge replacement project is eligible for use of Federal Highway Administration (FHWA) Highway Bridge Rehabilitation and Replacement (HBRR) funds.

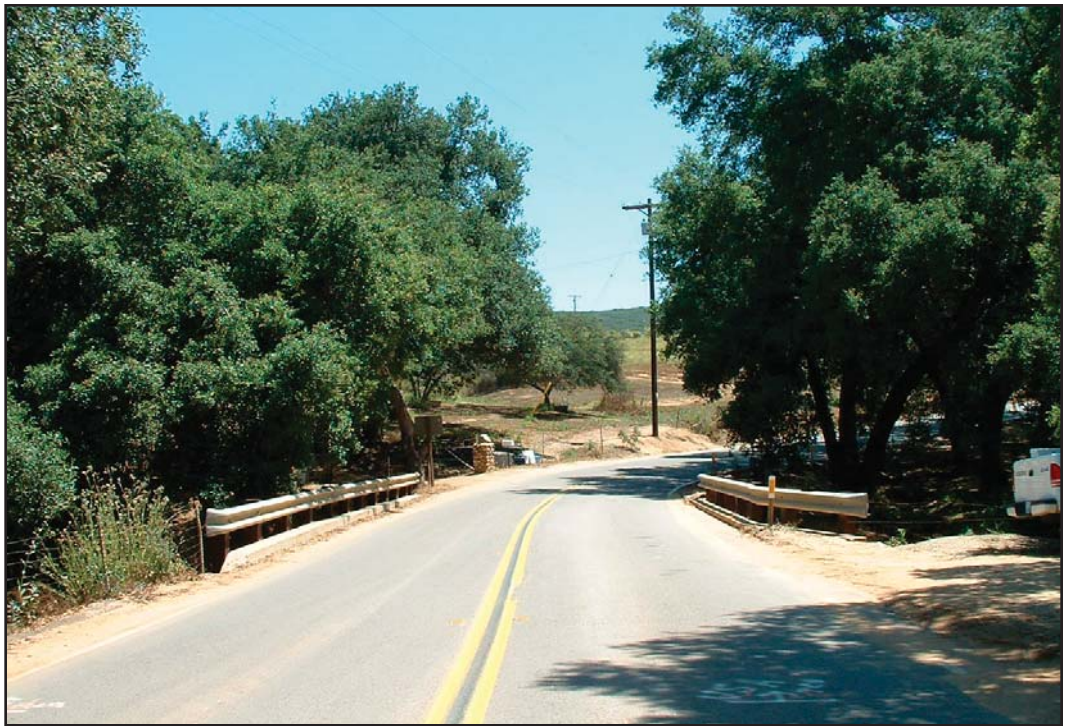
PHOTOGRAPH 1
Lawson Valley Road Bridge Looking West (2003)

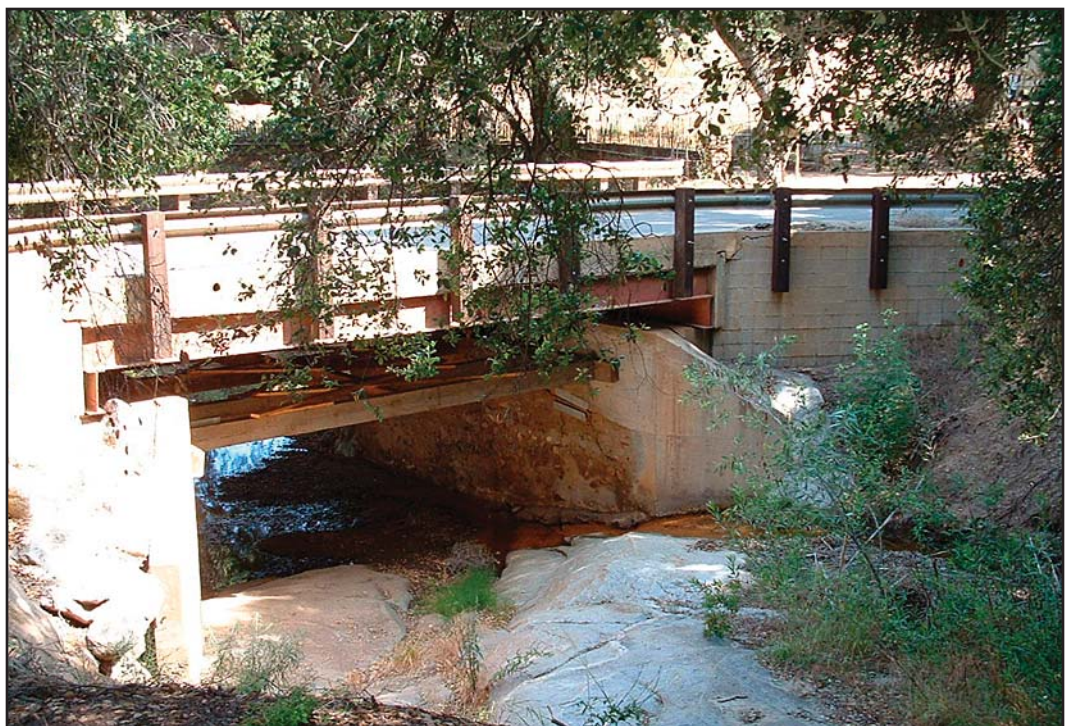
PHOTOGRAPH 2
Lawson Valley Road Bridge Looking West - Side View (2003)

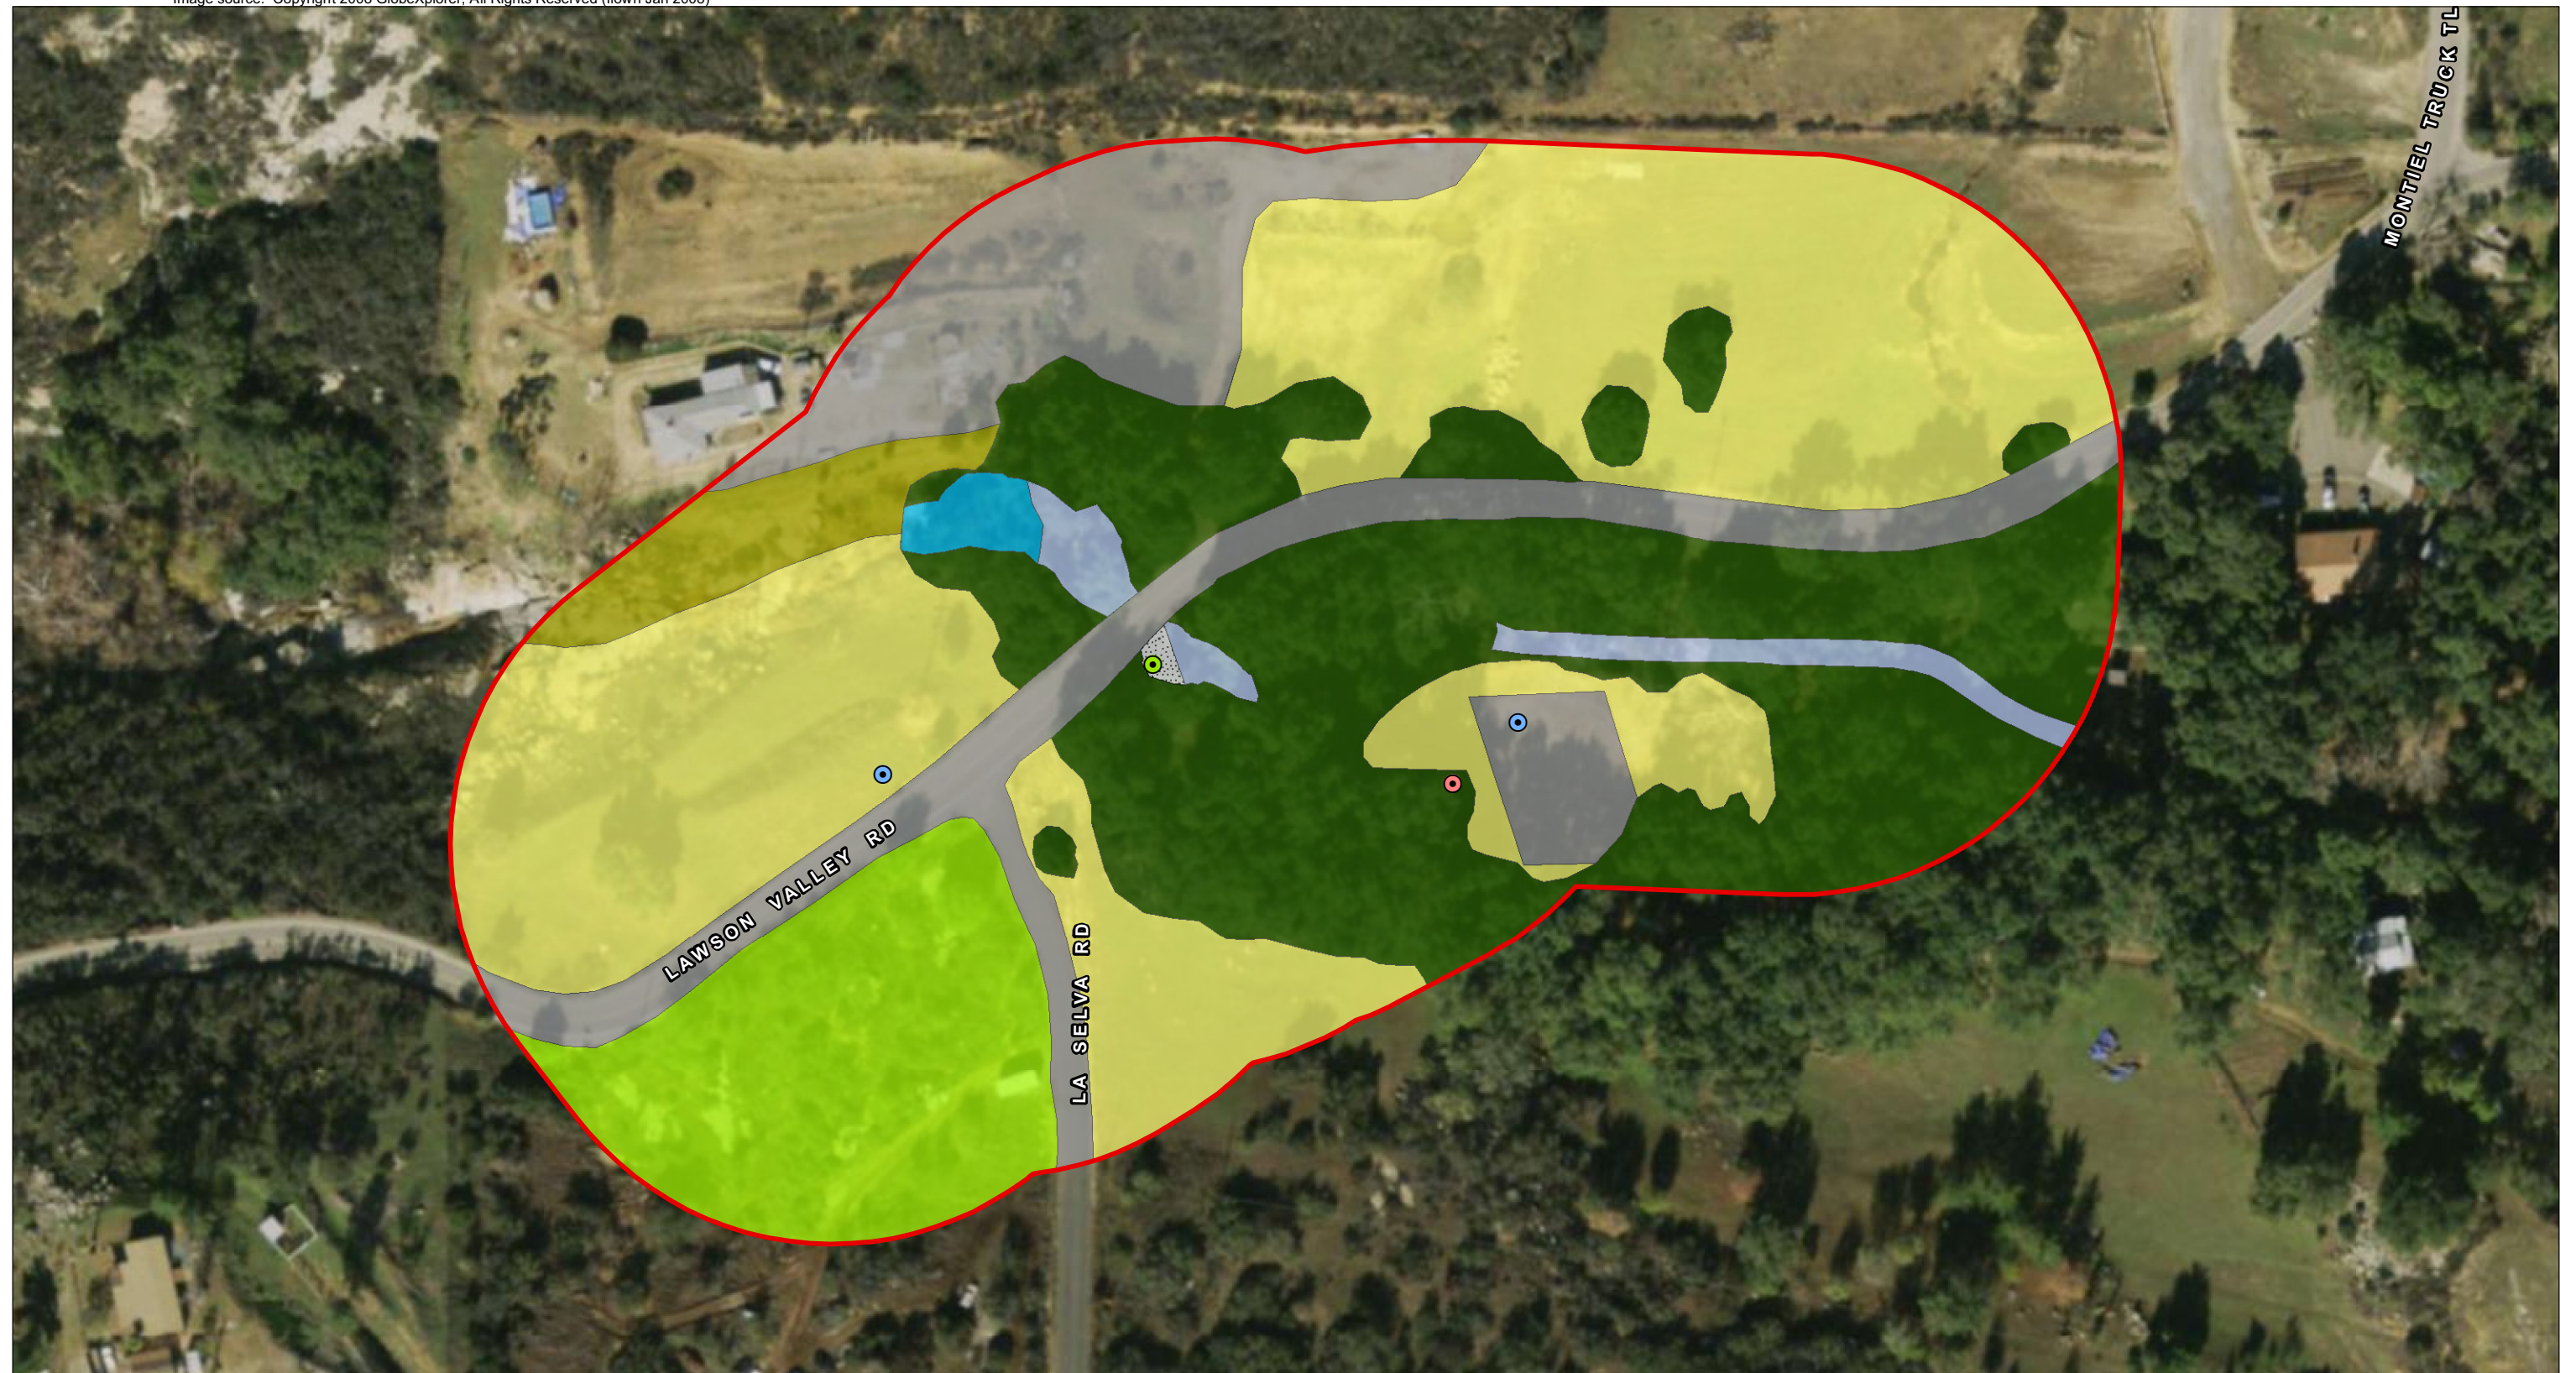
FIGURE 5
Vegetation Communities and Sensitive Species within
the Lawson Valley Road Bridge Project Study Area

Coast live oak riparian forest vegetation, totaling approximately 0.50 acre within the PIA, dominates the central portion of the study area along Lawson Valley Creek (see Figure 5). The coast live oak canopy cover is dense, with 85 to 90 percent canopy cover (Photograph 3). Plant species found within the understory include wild grape (*Vitis girdiana*), climbing penstemon (*Keckiella cordifolia*), creeping snowberry (*Symphoricarpos mollis*), California rose (*Rosa californica*), and non-native species such as wild oat (*Avena fatua*) and crabgrass (*Digitaria sanguinalis*).

Southern willow scrub, totaling 0.04 acre within the PIA, occurs along the streambed of Lawson Creek within the eastern portion of the study area (see Figure 5). Willow trees (spp.) form a continuous canopy with the adjacent coast live oak riparian forest

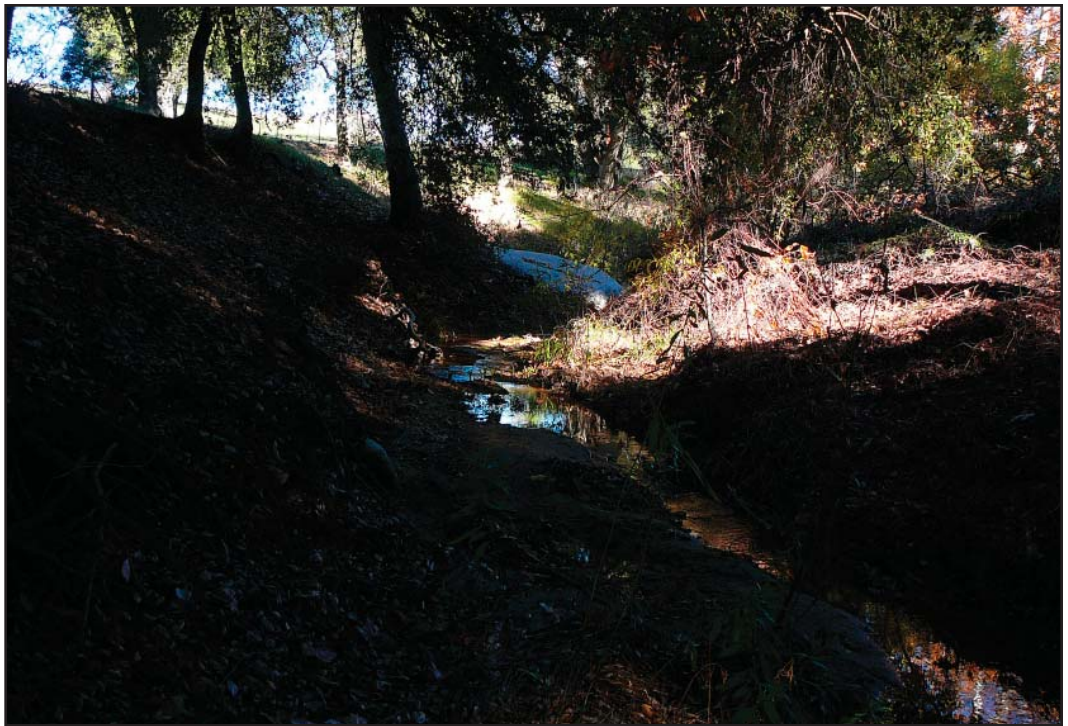
PHOTOGRAPH 3
Coast Live Oak Riparian Forest and Creek, Upstream From Bridge,
Facing East (2008)

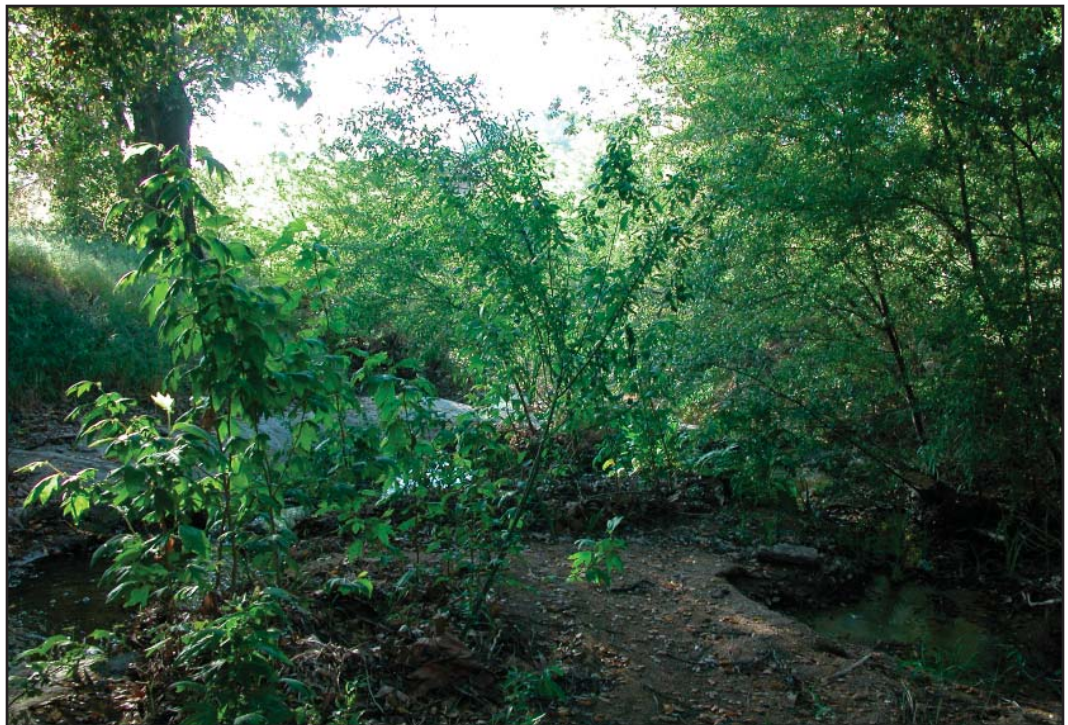
PHOTOGRAPH 4
Southern Willow Scrub, Downstream from Bridge, Facing West (2008)

(Photograph 4). Dominant native tree species include arroyo willow (*Salix lasiolepis*) with scattered emergent California sycamore (*Platanus racemosa*). An herbaceous understory is also present and dominated by mule fat (*Baccharis salicifolia*), western ragweed (*Ambrosia psilostachya*), paniced bulrush (*Scirpus microcarpus*), and western white clematis (*Clematis ligusticifolia*).

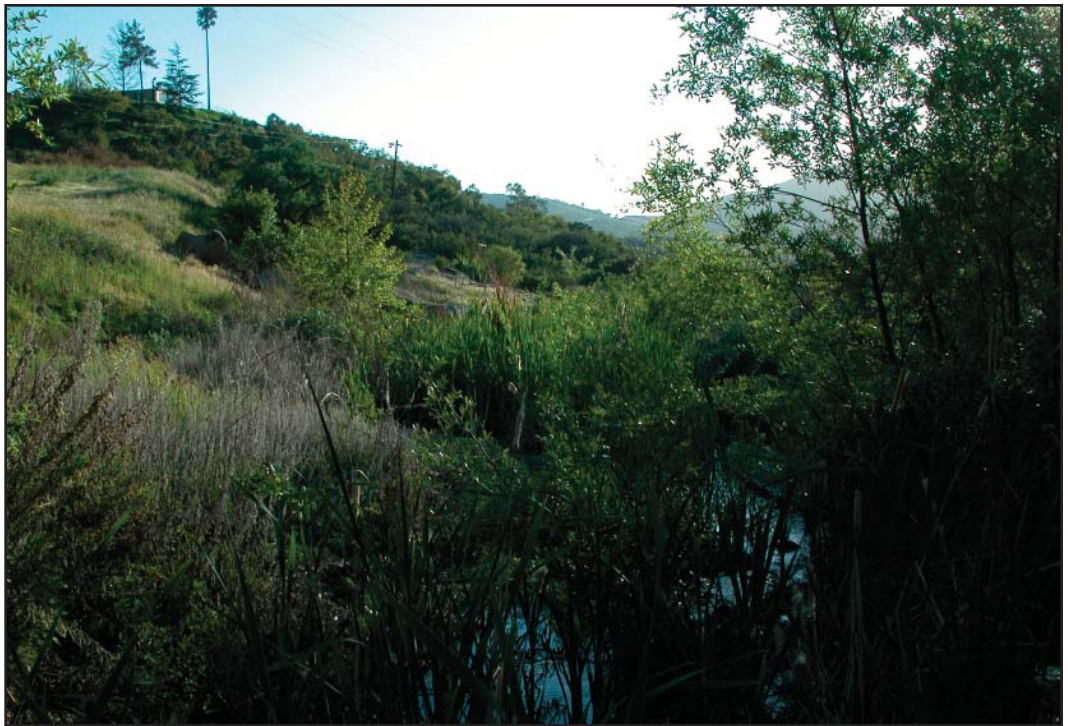
PHOTOGRAPH 5

Freshwater Marsh Downstream from Bridge, Facing Southwest with Non-native Grassland to the South, Southern Willow Scrub to the North, and Southern Mixed Chaparral in the Far Background (2008)

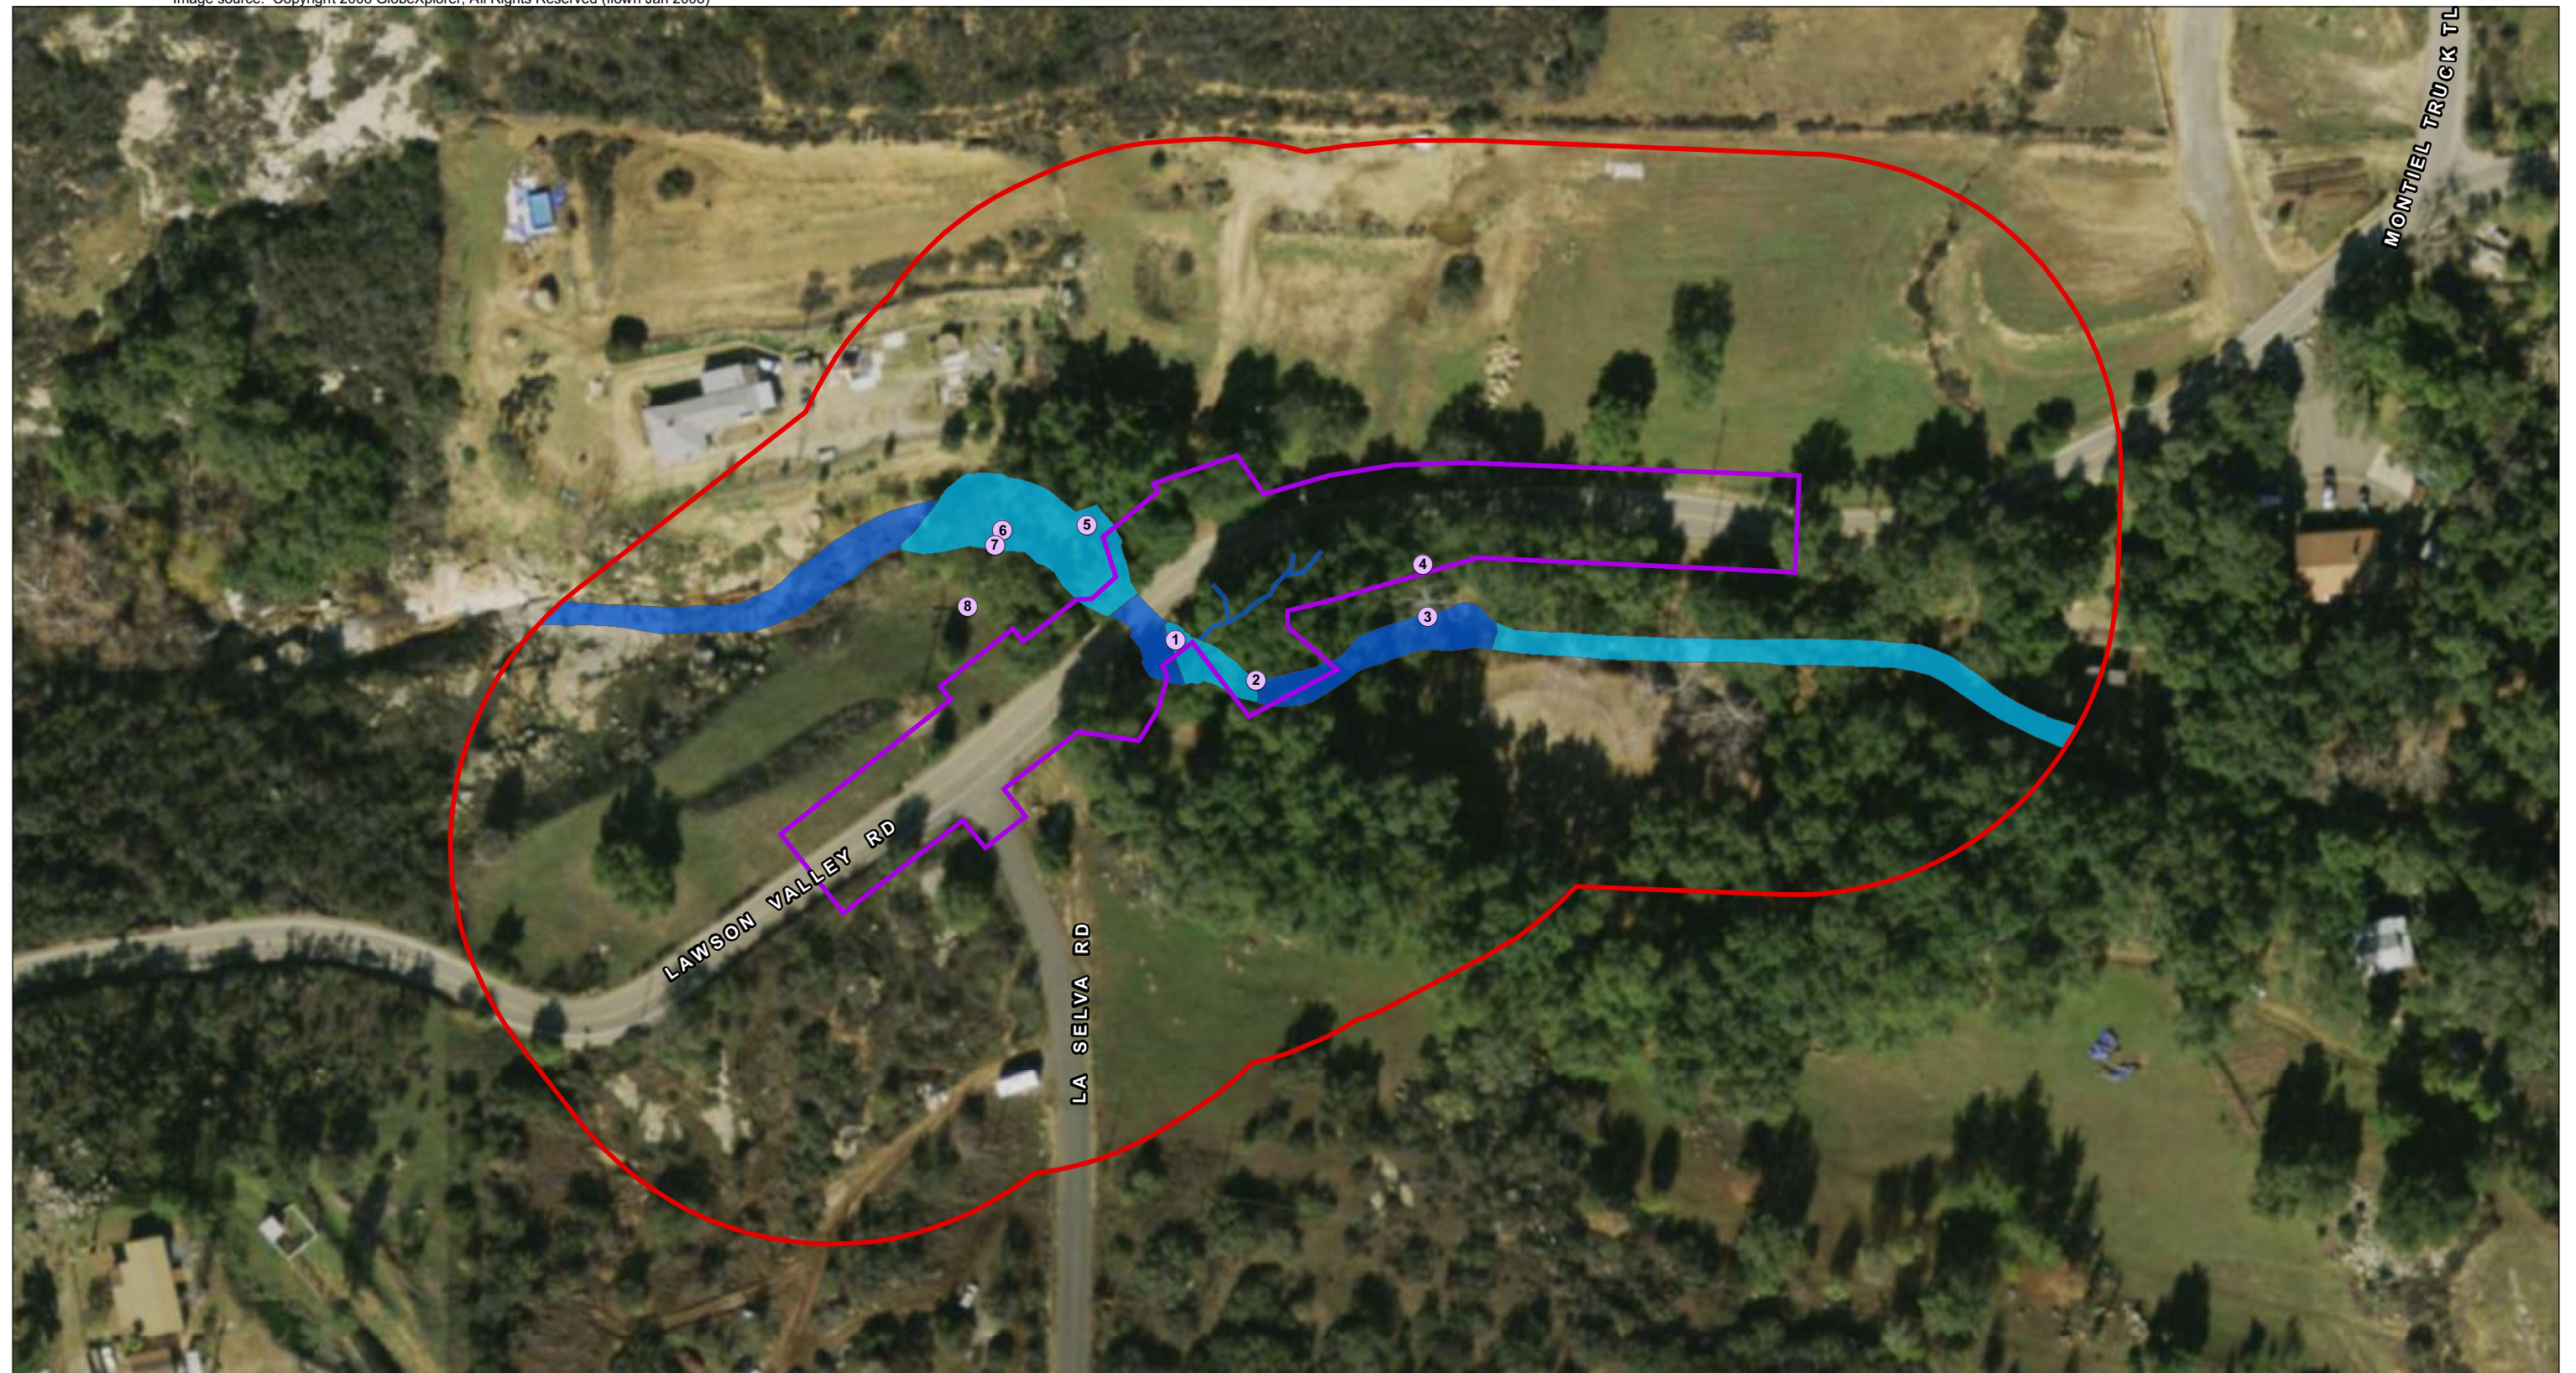
FIGURE 7A
Existing ACOE Jurisdictional Waters within the
Lawson Valley Road Bridge Project Study Area

Eight soil test pits were excavated in and adjacent to Lawson Valley Creek within the study area to determine the extent of the hydric soils. The locations of these test pits are shown in Figures 7a and 7b. Test Pits 1 and 5 were located upstream and downstream of the bridge on sandbars within the creek channel, approximately two feet from flowing water. Test Pits 2, 3, 6, and 7 were located adjacent to transitional wetland areas along the bank of the creek. Test Pits 4 and 8 were located upland from the creek underneath the oak tree canopy.

The presence of an ordinary high watermark and a connection to the Pacific Ocean were used to determine the jurisdictional status of Lawson Valley Creek and the connecting ephemeral drainage. As indicated by wetland vegetation, hydrology, and developing hydric soils, wetland habitat has formed within the creek both upstream and downstream of the bridge. Within the PIA, approximately 0.036 acre of Lawson Valley Creek falls under the jurisdiction of ACOE wetlands. Furthermore, 0.046 acre (575 linear feet) of the streambed and connecting ephemeral drainage (Photograph 7) meets the criteria for ACOE non-wetland waters of the U.S. (see Figure 7a). The total

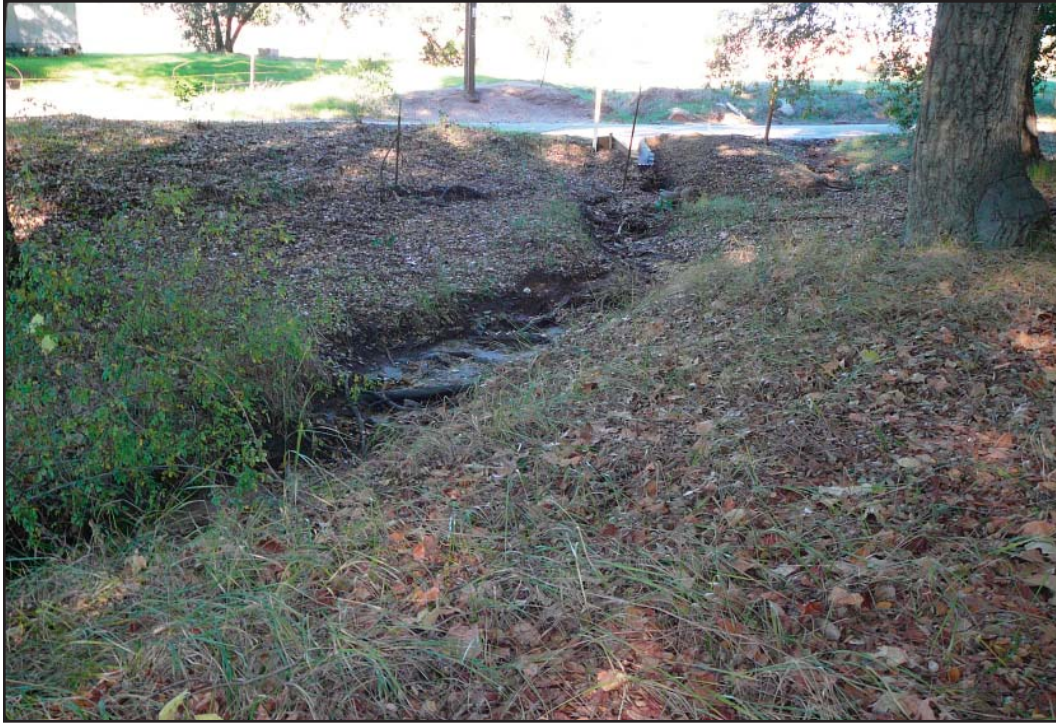
PHOTOGRAPH 7

Ephemeral Drainage Leading from Road Upstream of Bridge, Facing
North from Lawson Valley Creek (2008)

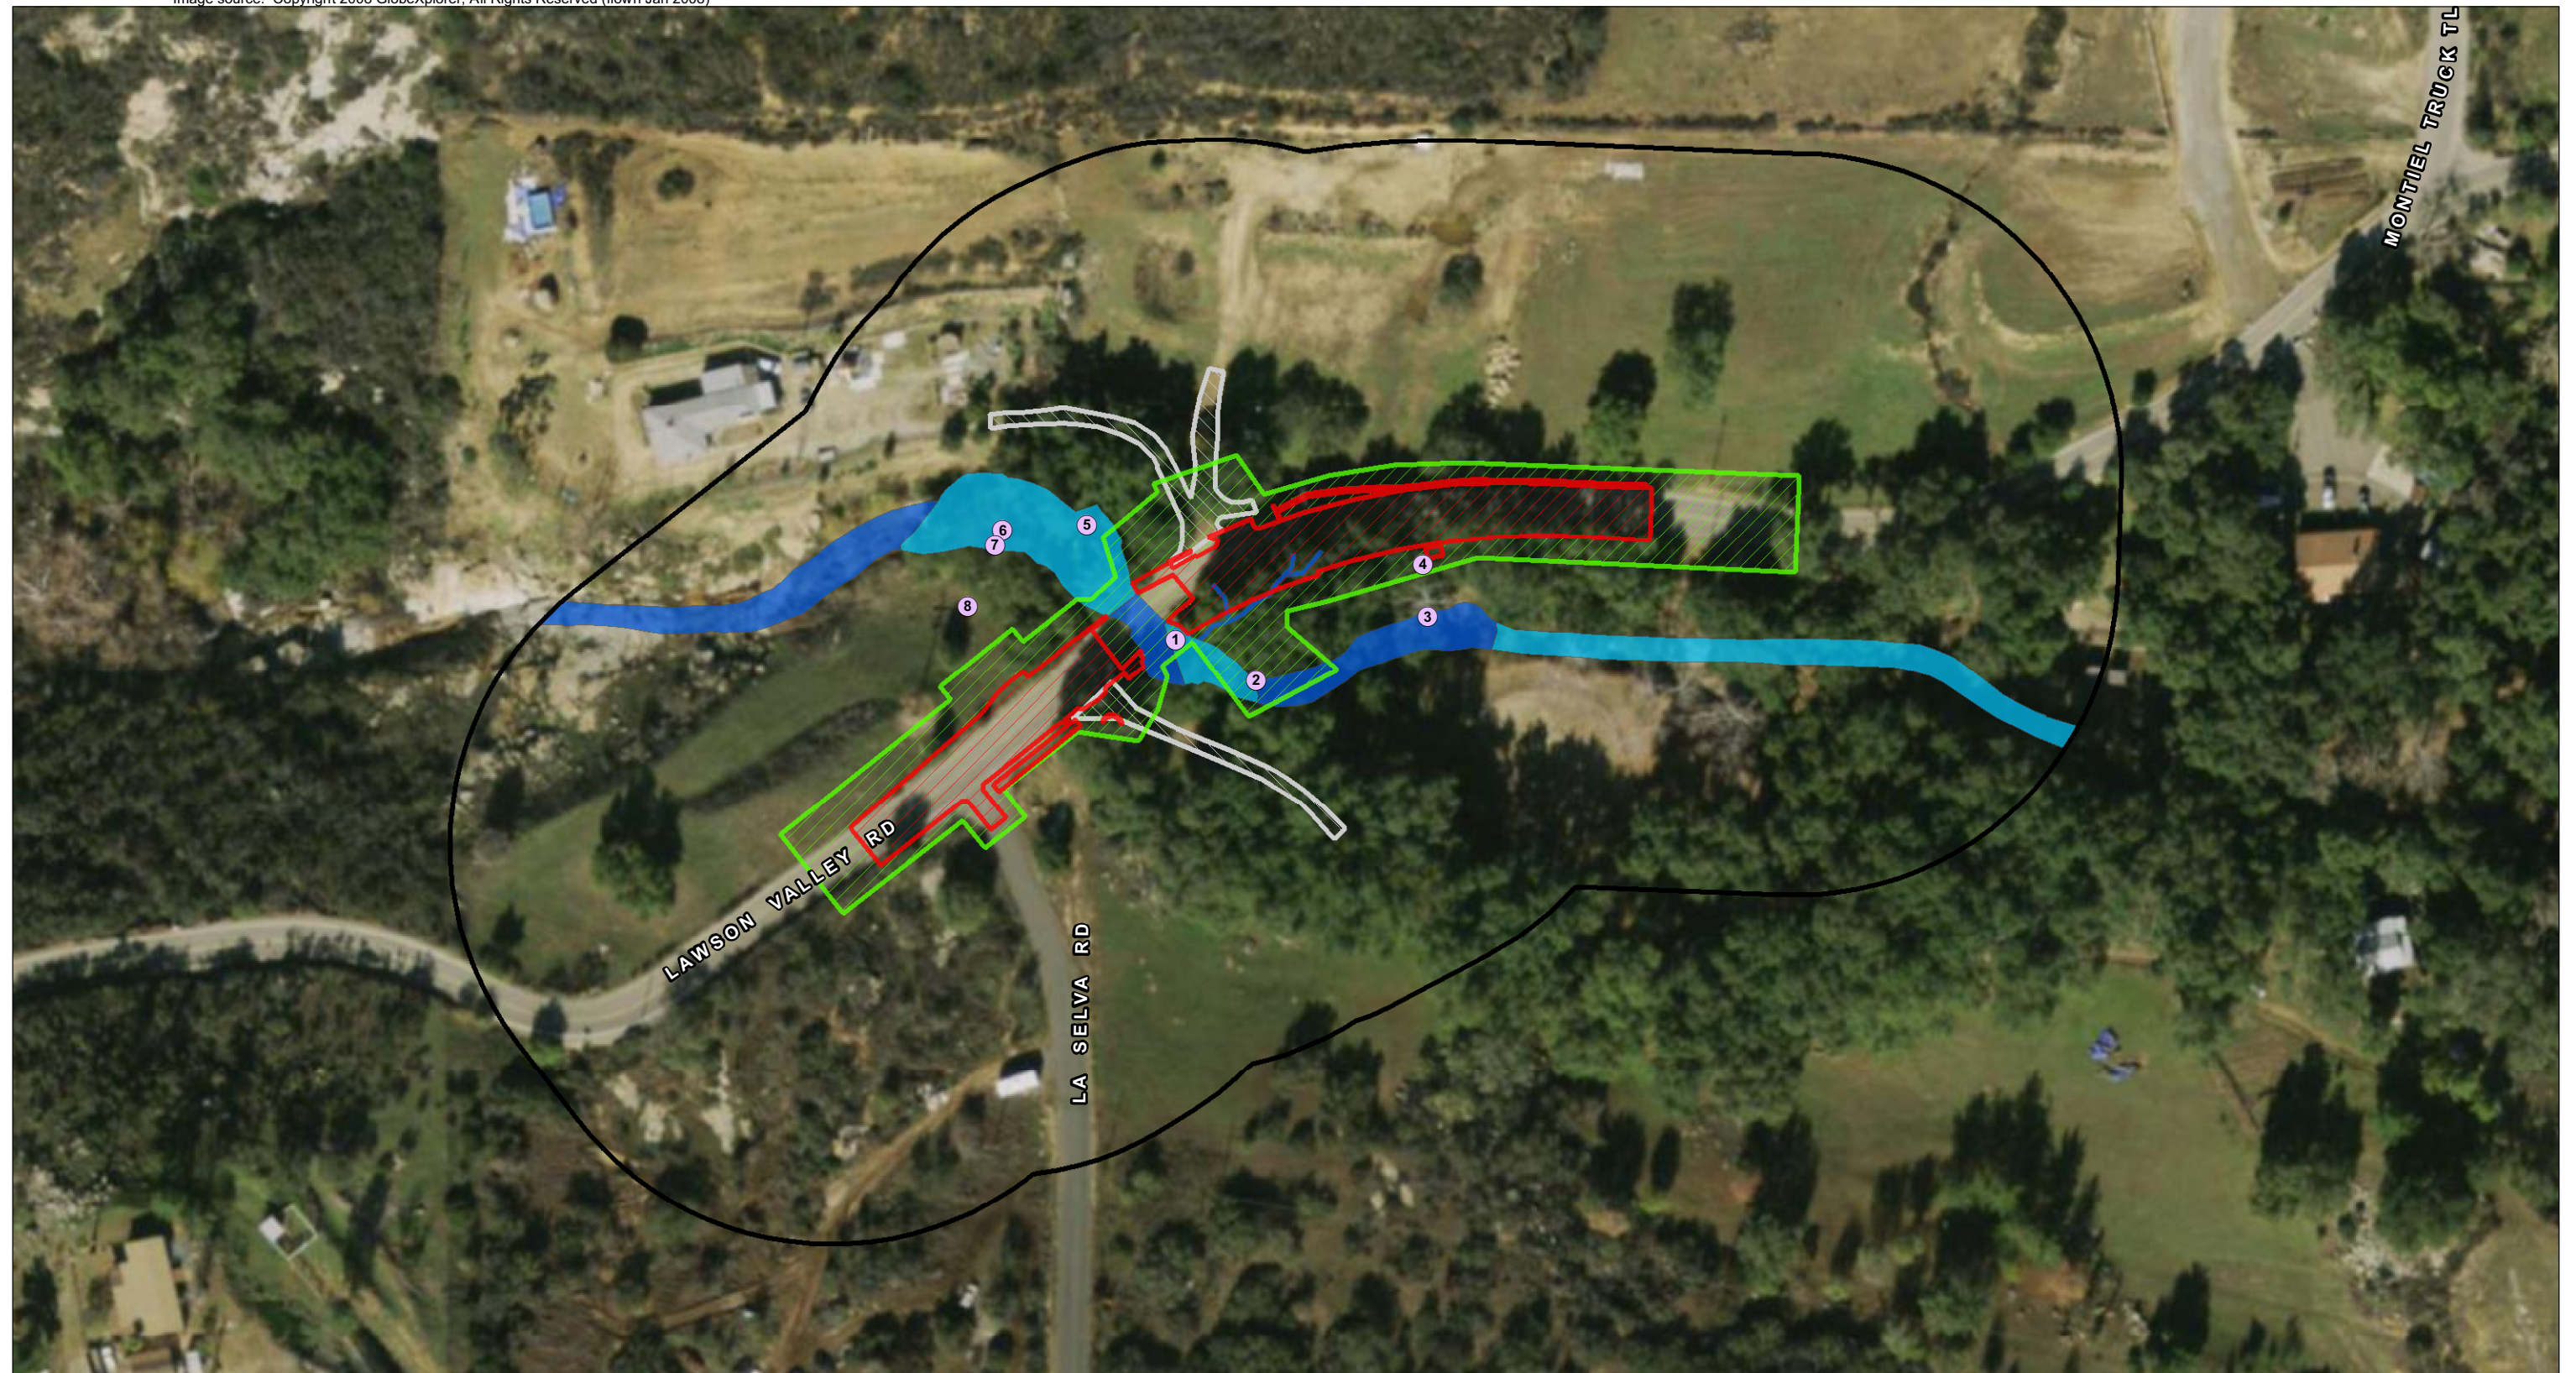
FIGURE 9A
Impacts to Existing ACOE Jurisdictional Waters
within the Lawson Valley Road Bridge Project Study Area

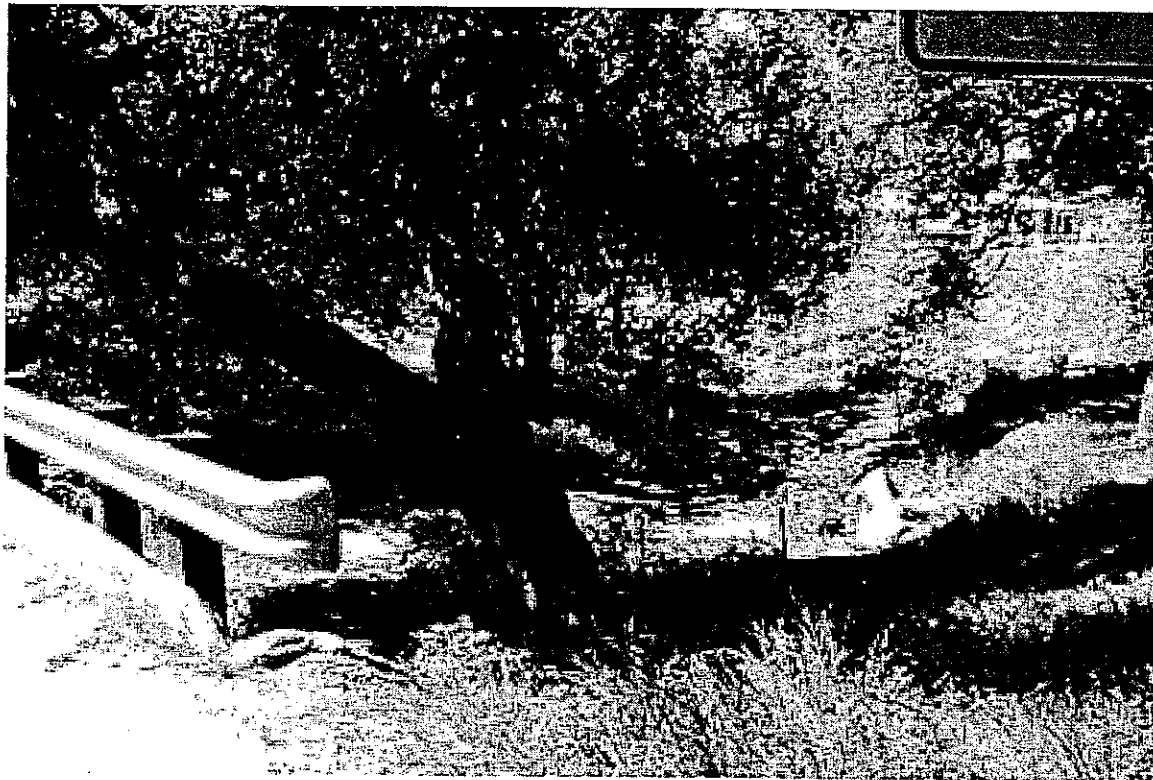
Figure B. Lawson Creek, downstream view of oak woodland (18 March 2003)

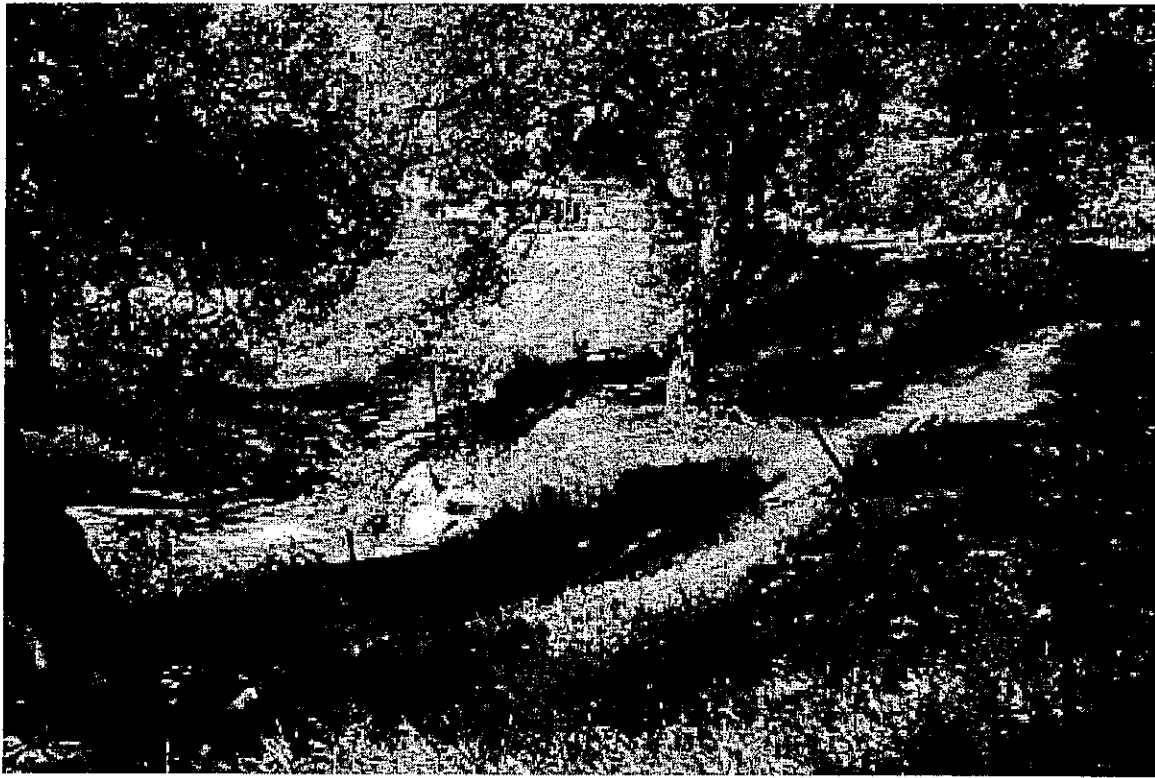
Figure C. Lawson Creek and attendant vegetation (18 March 2003)

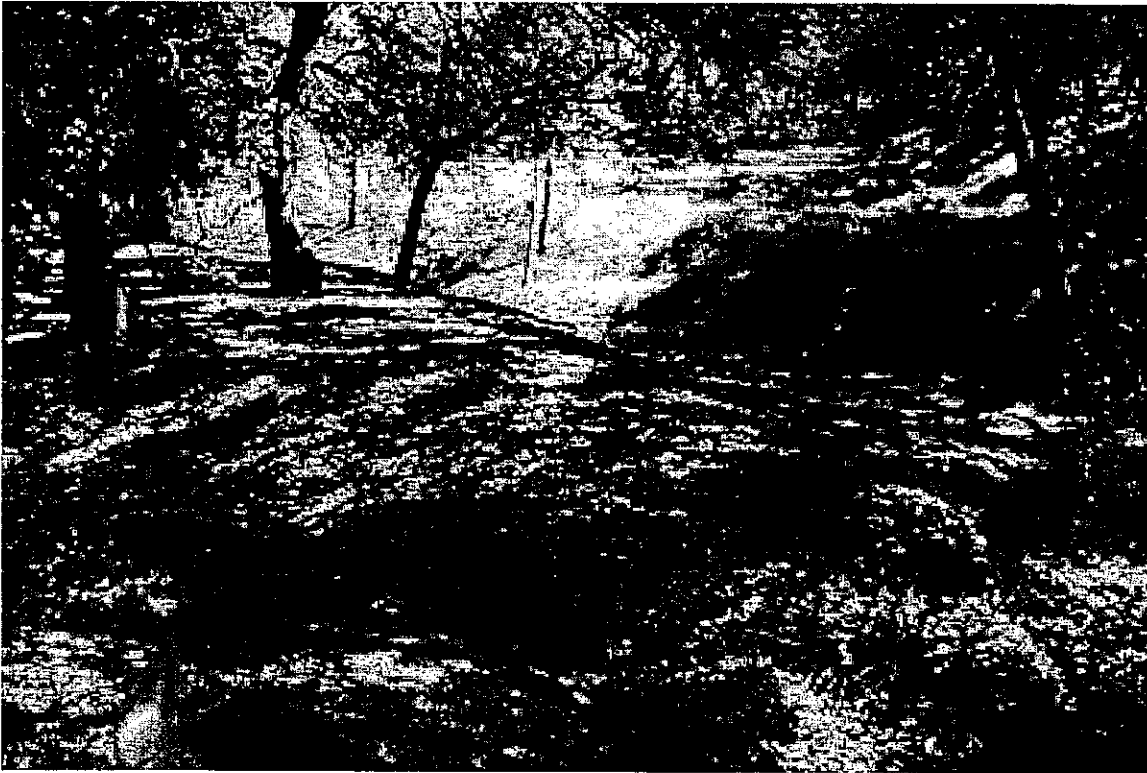
Figure D. Lawson Creek, three days after 2-inch rainfall of 15 March 2003

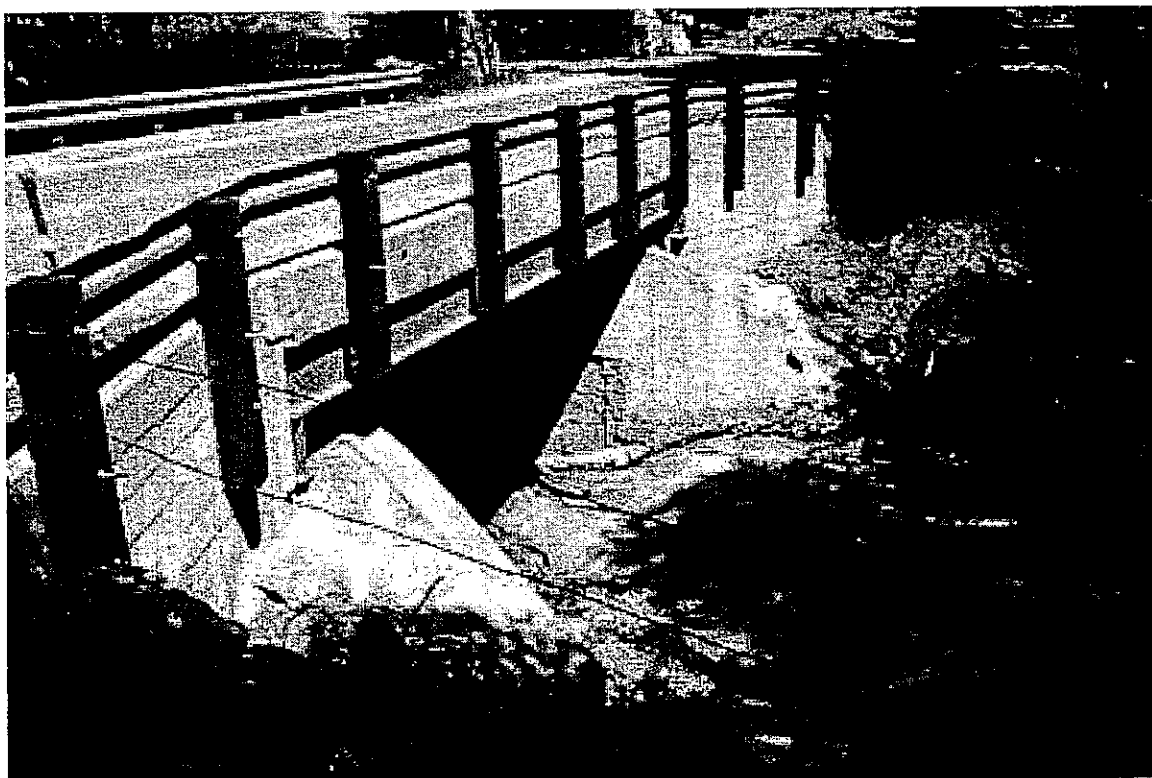
Figure E. Lawson Creek at Lawson Valley Bridge (18 March 2003)
